SCHILLER POND DAM

PHASE 1 INSPECTION REPORT NATIONAL DAM SAFETY PROGRAM

MAY 1981

Name: Schiller Pond Dam, I.D. NJ 00153
State Located: New Jersey
County Located: Hunterdon County
Stream: Tributary Alexanken Creek
River Basin: Delaware River
Date of Inspection: January 13, and February 3, 1981

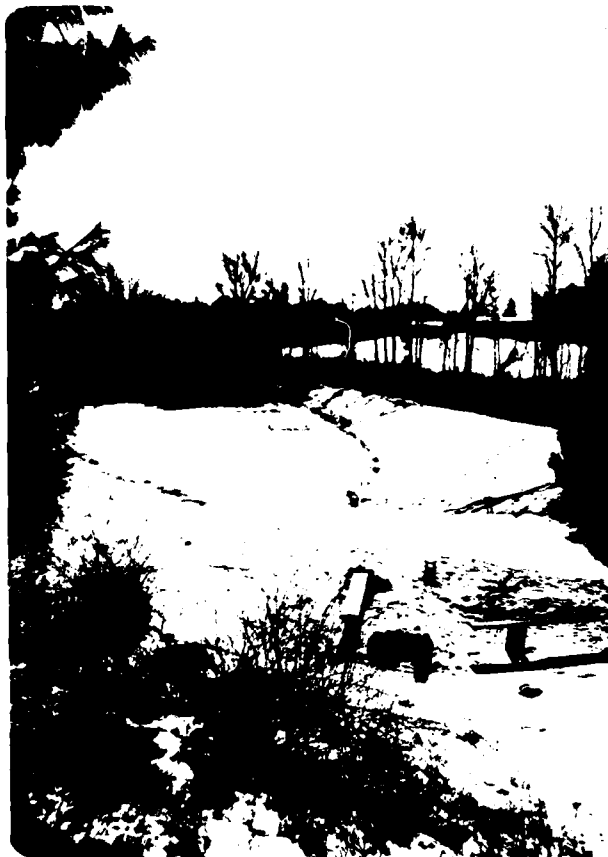
There are no signs of distress in the embankment of the Schiller Pond Dam. The trees growing on the embankment at the junction with the auxiliary spillway could pose a threat to stability. The spillways are in good condition.

Photo 1 - View of dam taken from right bank of auxiliary spillway. Note clump of trees on embankment in right of photo. (Photo taken on January 13, 1961.)

3. The trees should be removed from the embankment slopes to avoid problems that may develop from roots. The area should then be seeded to develop a growth of grass for surface erosion protection. This should be done within twelve months.
4. Determine if the low-level outlet gate is operable, and if not institute remedial action to make it operable within twelve months.
5. The owner should develop an emergency action plan (if one is not already available) outlining actions to be taken by the operator to minimize downstream effects of an emergency and establish a flood warning system for the downstream communities within three months.
